AlphaServer 2x00, 2x00A Loadable Firmware Update Utility User Guide and Release Notes

For **AlphaServer 2x00 Model 4/xxx**

For **AlphaServer 2x00 Model 5/xxx**

For **AlphaServer 2100A Model 4/xxx**

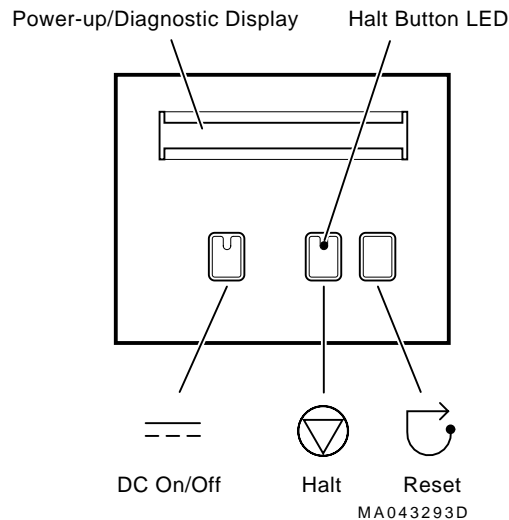
Figure 3-1 AlphaServer 2000/AlphaServer 2100/AlphaServer 2100A Operator Control Panel

Once the operating system has been shutdown, halt the system by pressing the HALT button to the "in" position on the Operator Control Panel. Refer to Figure 3-1.

Ensure a known initialized state by cycling power or performing a hardware reset with either the DC ON or the RESET button on the Operator Control Panel. (Refer to Figure 3-1.) At this point the system will reset, rerun diagnostics, and return to the console prompt.
